CHARLES RIVER BASIN
HOLLISTON, MASSACHUSETTS

HOUGHTON POND DAM
MA 00444

PHASE I INSPECTION REPORT
NATIONAL DAM INSPECTION PROGRAM

JULY 1979

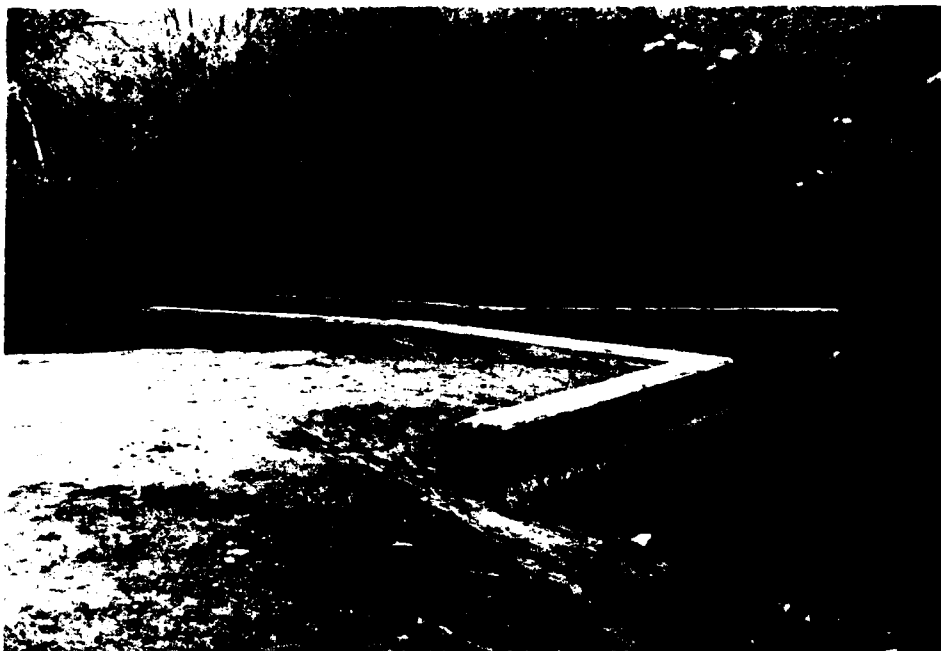
c. Appurtenant Structures. The concrete main spillway (outlet) with stoplogs is located to the left of the stone masonry auxiliary spillway. Considering the different mode of construction between the concrete spillway and the auxiliary spillway, it can be concluded that the concrete spillway was constructed some time after the auxiliary spillway. The concrete portion of the structure is in good condition with some minor spalling and staining observed, Photos No. 8, 9, 10 and 11.

8. Concrete main spillway (outlet) structure.
Note erosion at left abutment

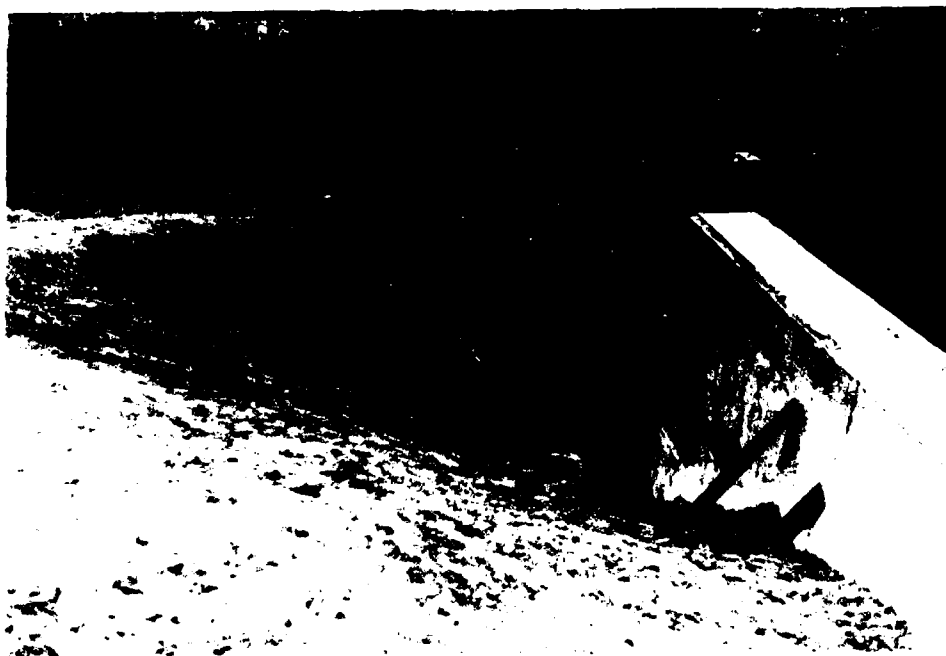
The severe erosion noted at the left abutment occurred over 10 years ago, possibly during the 1968 storm, according to Mr. Douglas Brown, the Holliston Building Inspector. This is a further indication of the lack of maintenance of the dam.

9. Severe erosion of abutment at downstream end
of left concrete wall

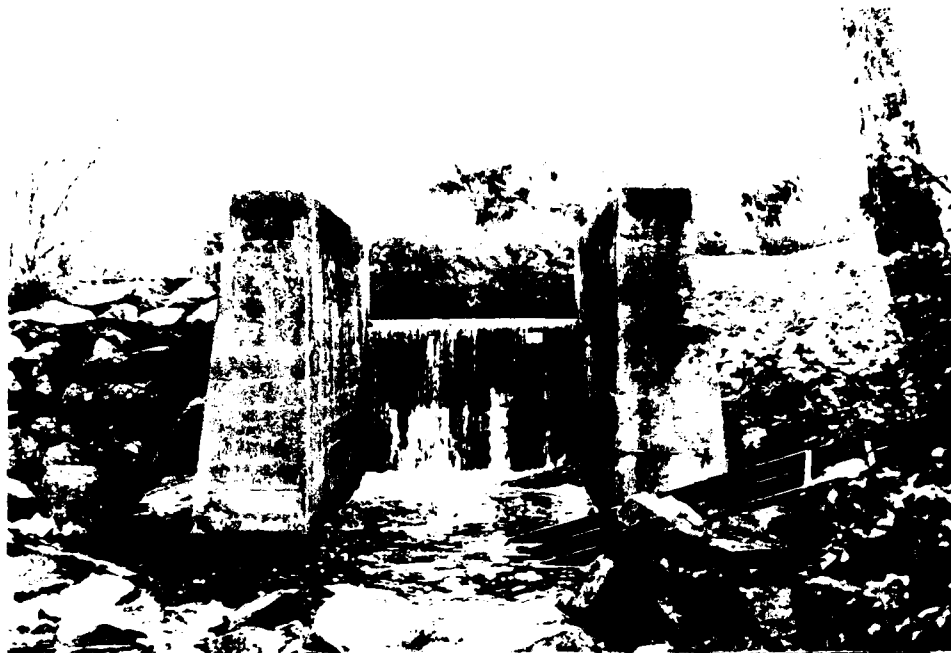
There are blockouts with anchor bolts observed on either side of the stoplog slots at the top of the concrete spillway walls, Photo No. 1. Observation of the stoplogs revealed the remains of two wooden stems bolted to the lower stoplogs. The presence of these stems and the blockouts at the top of the walls would tend to indicate that what appears to be stoplogs may have been a double-stem operated (through rack and pinion gears) wooden gate. The condition of the stoplogs (remains of a wooden gate) are poor, with several leaks observed between the lower stoplogs, Photo No. 10. Remnants of one of the stoplogs could be seen in the channel below.

10. Leakage between stoplogs at main spillway (outlet)

6. Replace the existing stoplogs (remains of a wooden gate) which are in poor conditions and leaking in a manner to assure ease of removal.
7. Remove debris in the channel below the spillways.

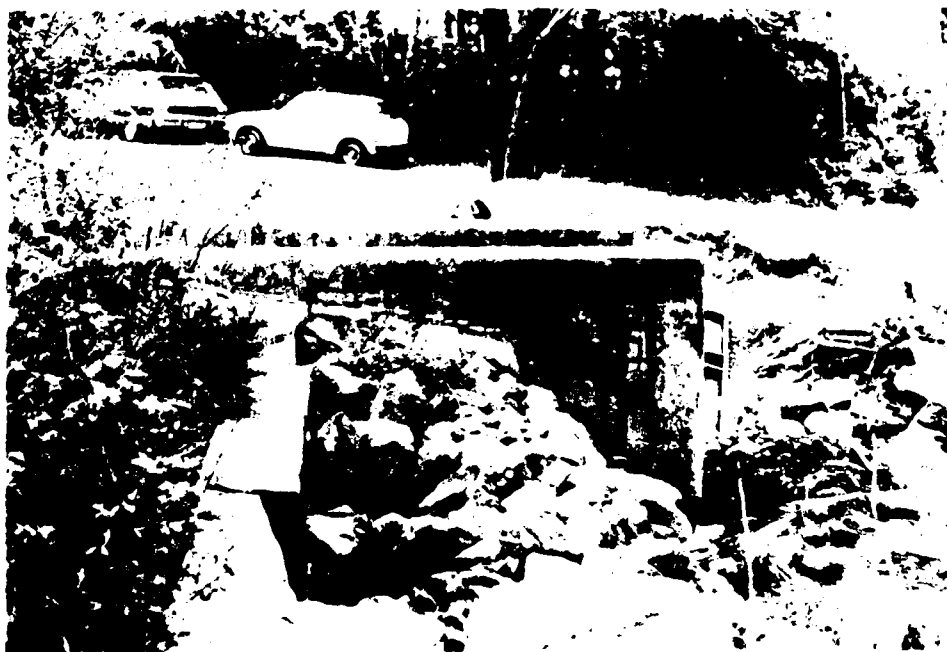
11. Gree-shaped, stone masonry auxiliary spillway right of concrete structure

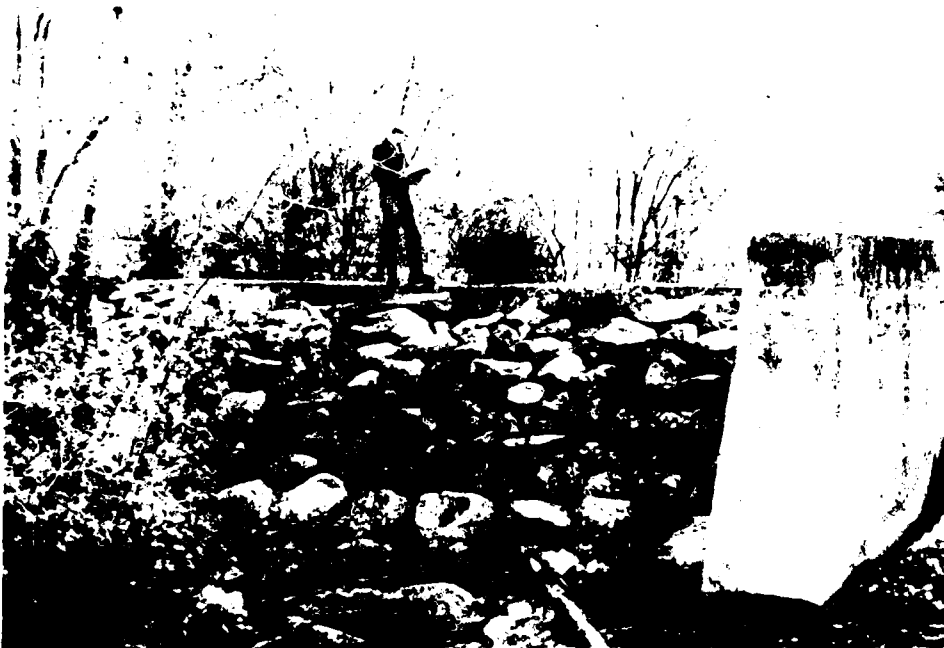
No. 1 and 11. The top of ground adjacent to the granite weir is from 6 to 15 in. below the top of the granite. At present water level, seepage is occurring below the granite cap and dry-laid boulders on the downstream face at a location 6 ft. right of the concrete spillway, Photo No. 12. It was not possible to trace the flow of water from this point to where it exited downstream. Numerous boulders immediately downstream of the granite weir are missing, either having been plucked out or removed by vandals, Photos No. 4 and 11. Otherwise, the stones appear to be relatively well chinked and are mostly present toward the lower part of the weir, Photo No. 13. Some light vegetation is growing on the downstream face.

13. Stone facing on downstream side of auxiliary spillway

5. Replace the stones missing from the ogee-shaped downstream face of the auxiliary spillway with consideration given to grouting the voids between the stones.
